**A STRUCTURAL HISTORY
OF THE
M. HAWRELIAK HOME
IN SHANDRO, ALBERTA**

**Occasional
Paper
No. 16**

March 1989

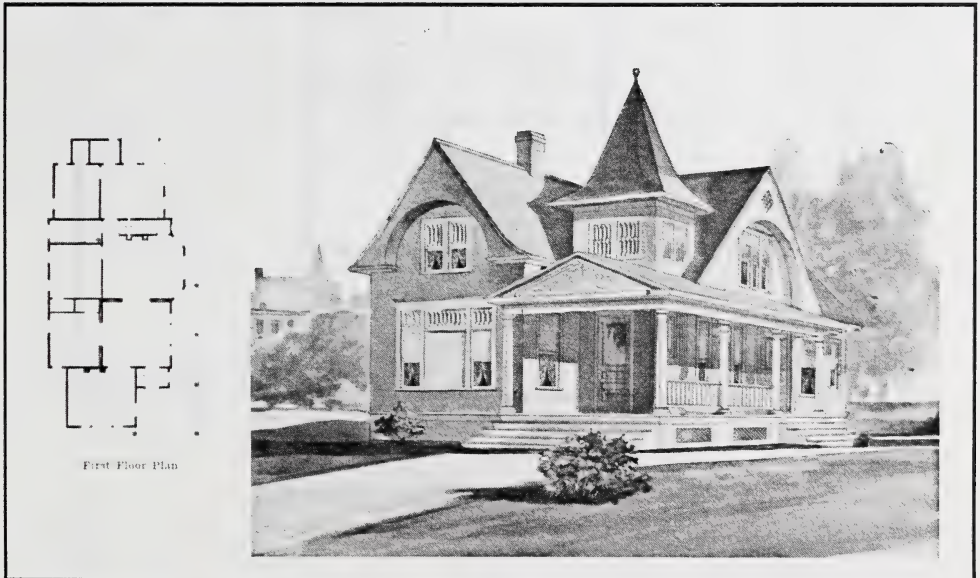
Figure 26: Design No. 2131-B in Radford's Artistic Bungalows

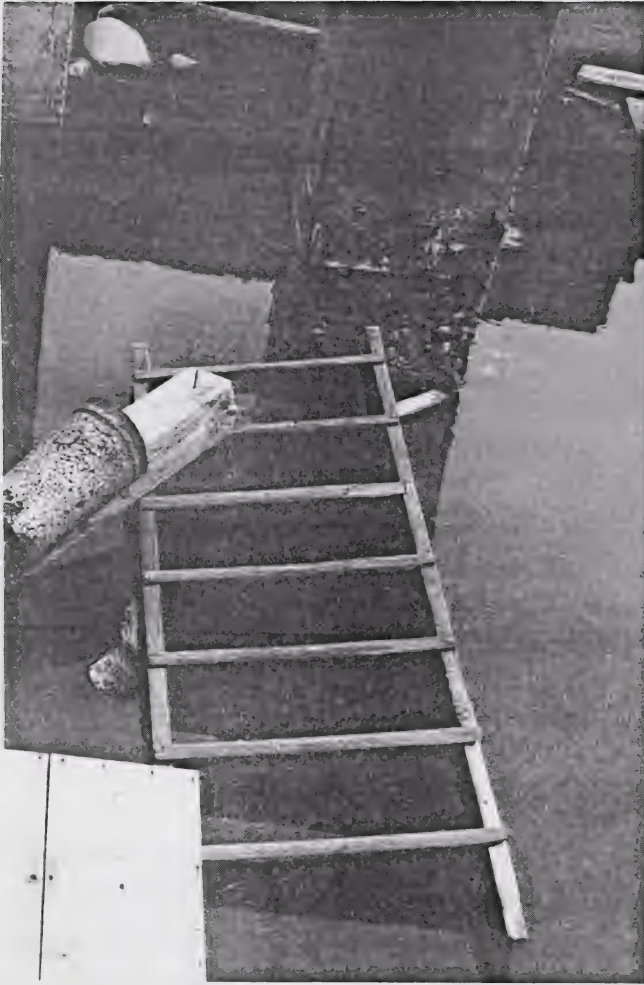
Figure 29: The basement steps.

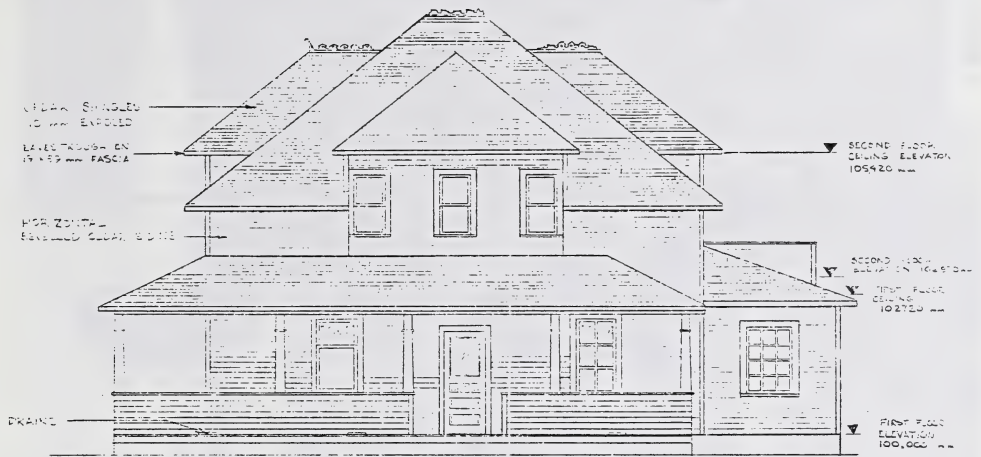
SOUTH ELEVATION

Figure 30: The south elevation of the Hawreliak house, showing the cresting on the roof ridges.

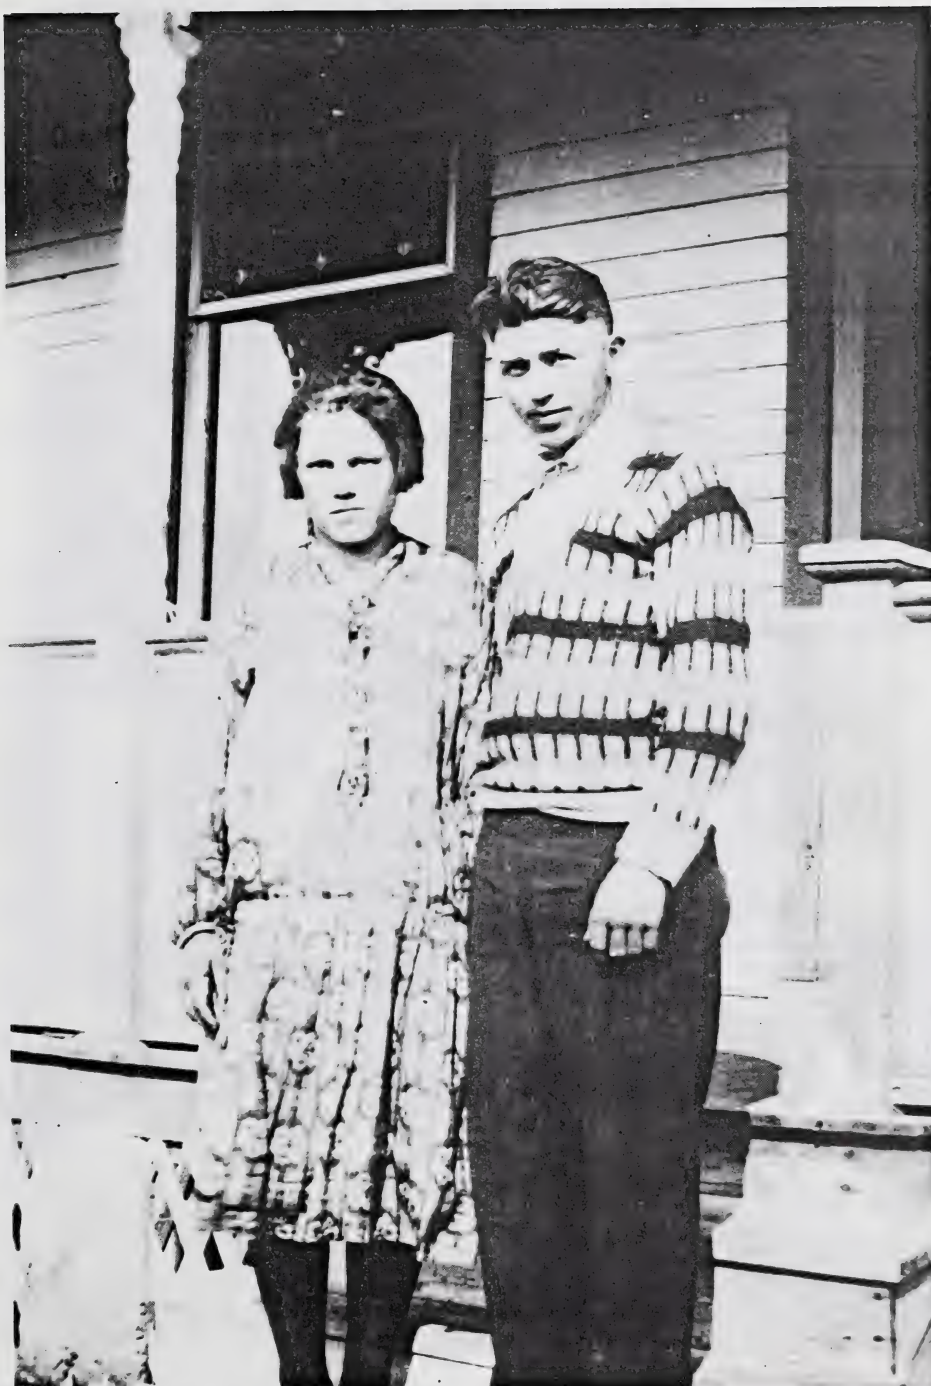
Figure 32: Mary Hawreliak and her fiancé, Metro Repka, on the west veranda, ca. 1927. The west bedroom window is visible in the background.

Historical photographs indicate that one of these tulip-patterned sashes was in the west bedroom (see Figure 32). Several informants believed that both windows in the west elevation contained the same type of stained glass.⁴⁷

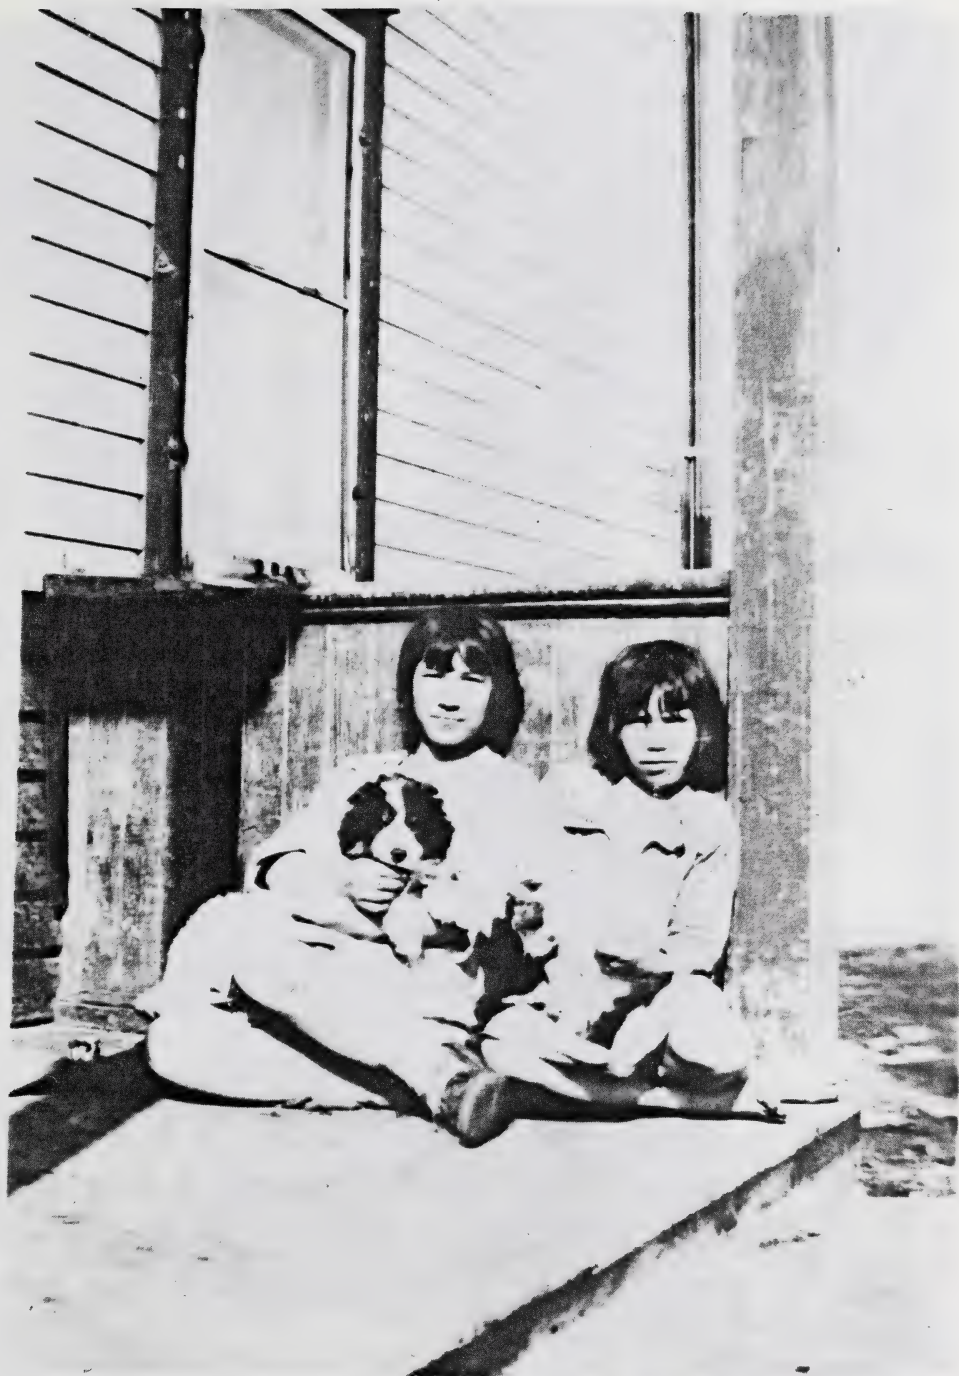
Figure 34: Lena (at right) and Kate Hawreliak and their pets, ca. 1930. The girls are sitting in the east entrance-way. Note the light-coloured storm sash in the window.

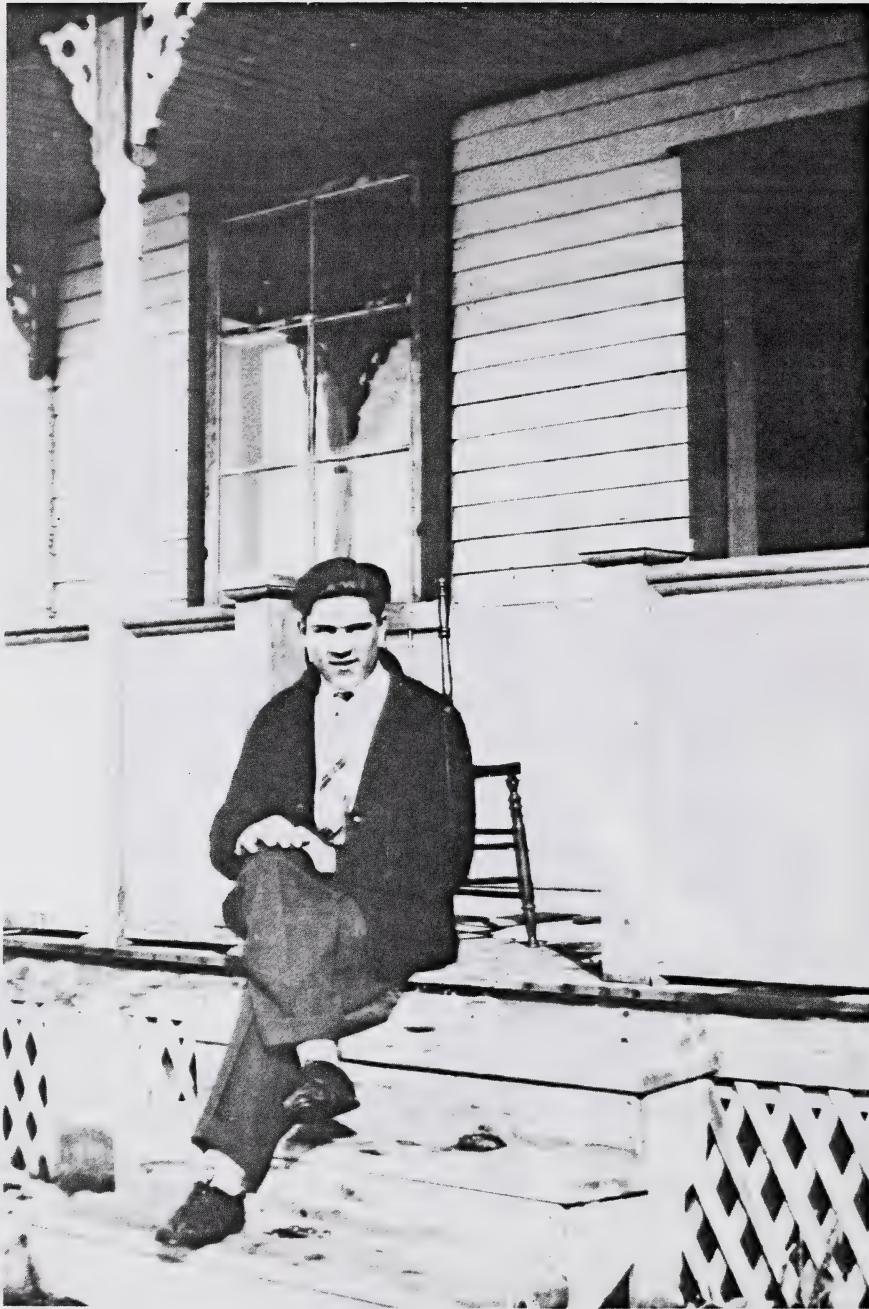
Figure 35: Nick Hawreliak on the west steps (pre-1933). Note the light-coloured storm sash in the window. If the light colour was due to weathering, it is likely that the sash and the window surround would have weathered to the same degree.

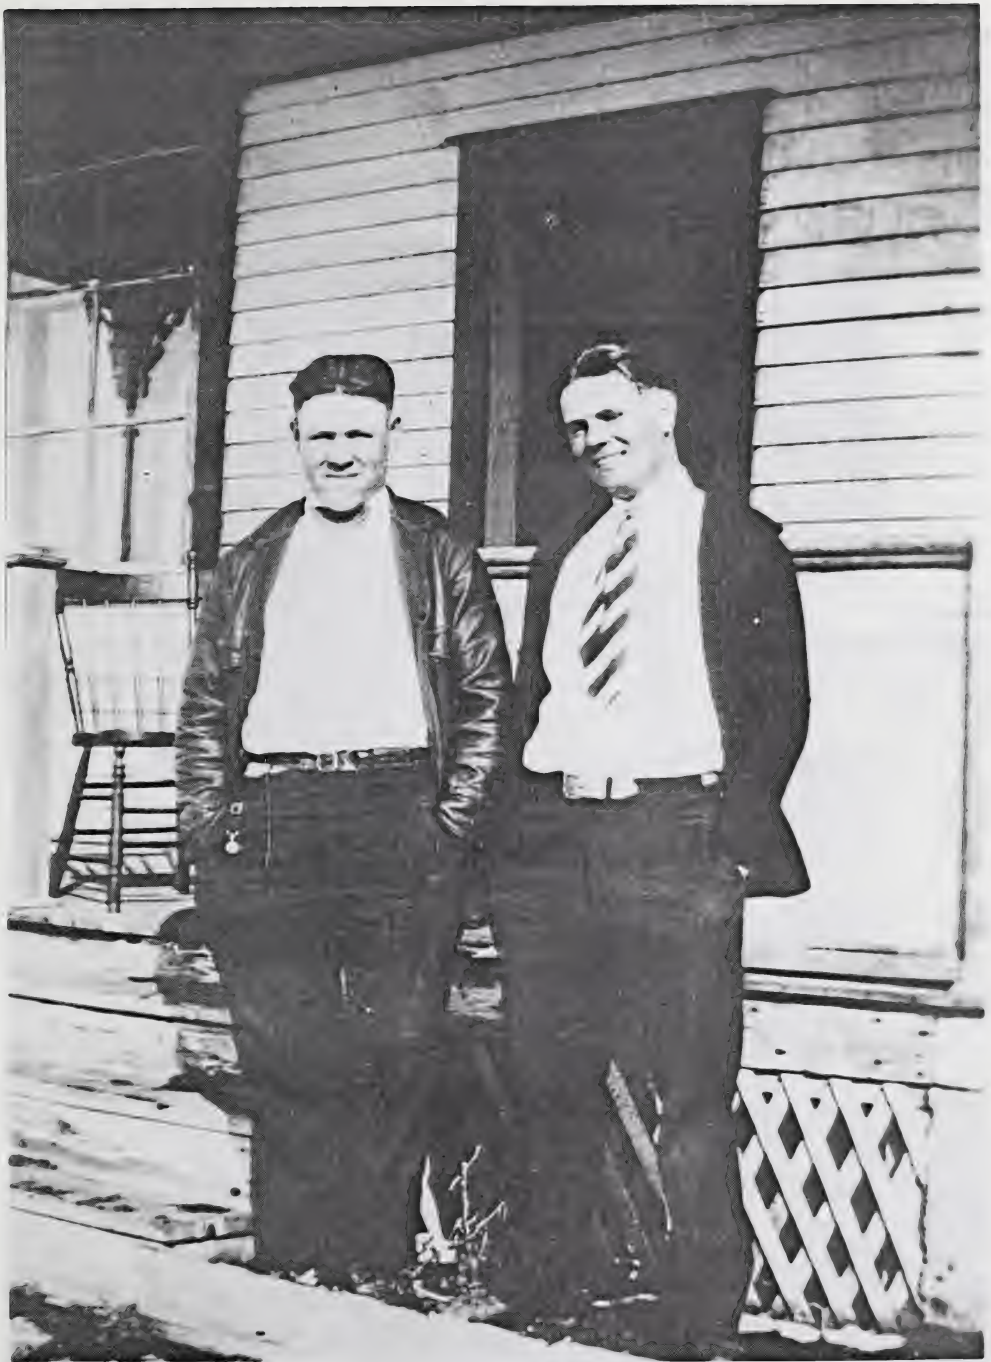
Figure 36: Mike Huculak (at left) and Bill Hawreliak on the west side of the house (pre-1933). Note the light-coloured storm sash in the window, and the flower bed border the men are standing behind.

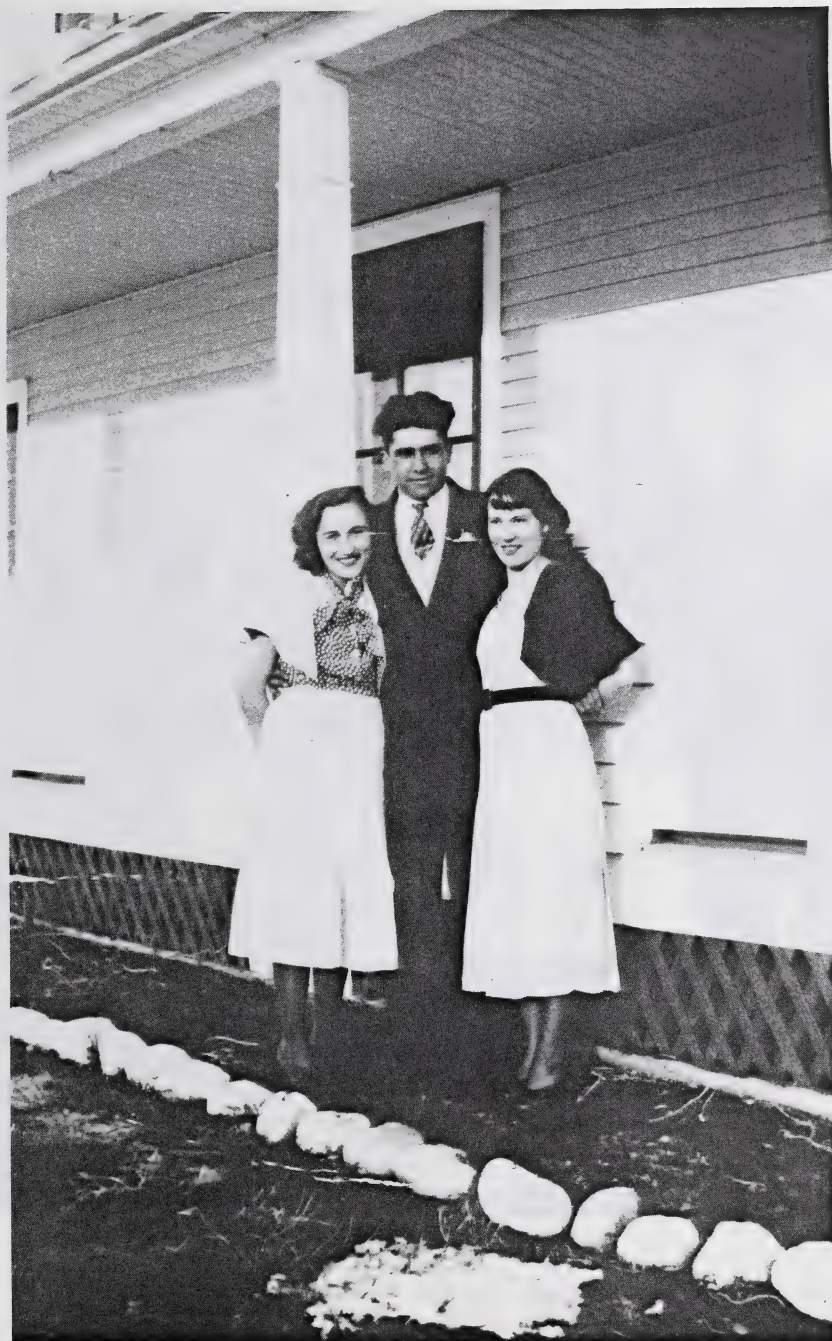
Figure 40: Eva (Megley) Hawreliak (at left), Nick Boychuk, and Nancy Hawreliak, April, 1936. Note the "remodelled" veranda and the undercuts in the base of the railing.

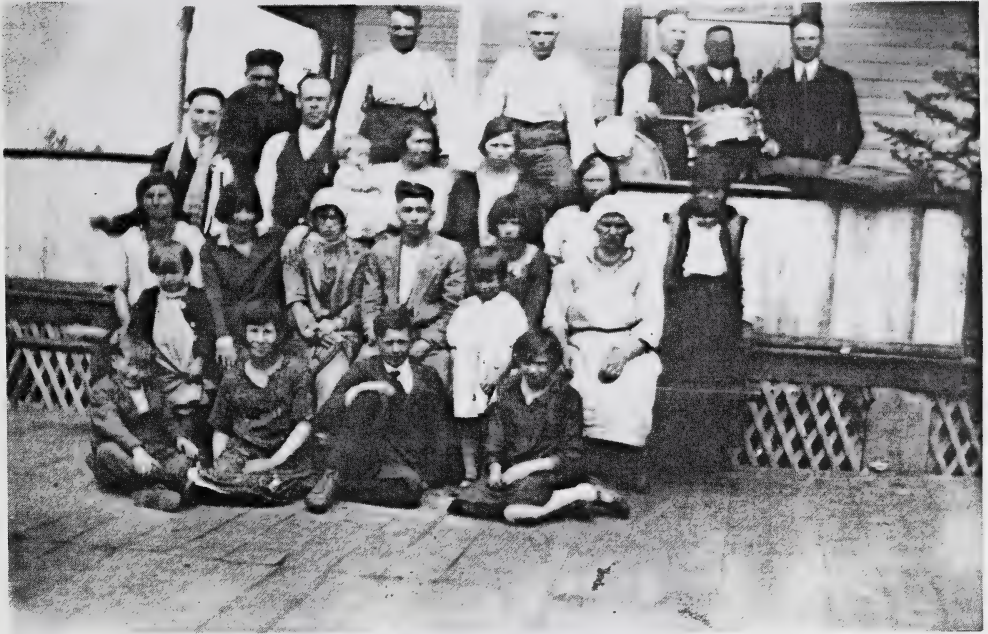
Figure 42: Family group on second day of Mary (Hawreliak) Repka's wedding, June 8, 1928. Note the missing lattice strips in the southwest corner of the veranda (i.e., at left).

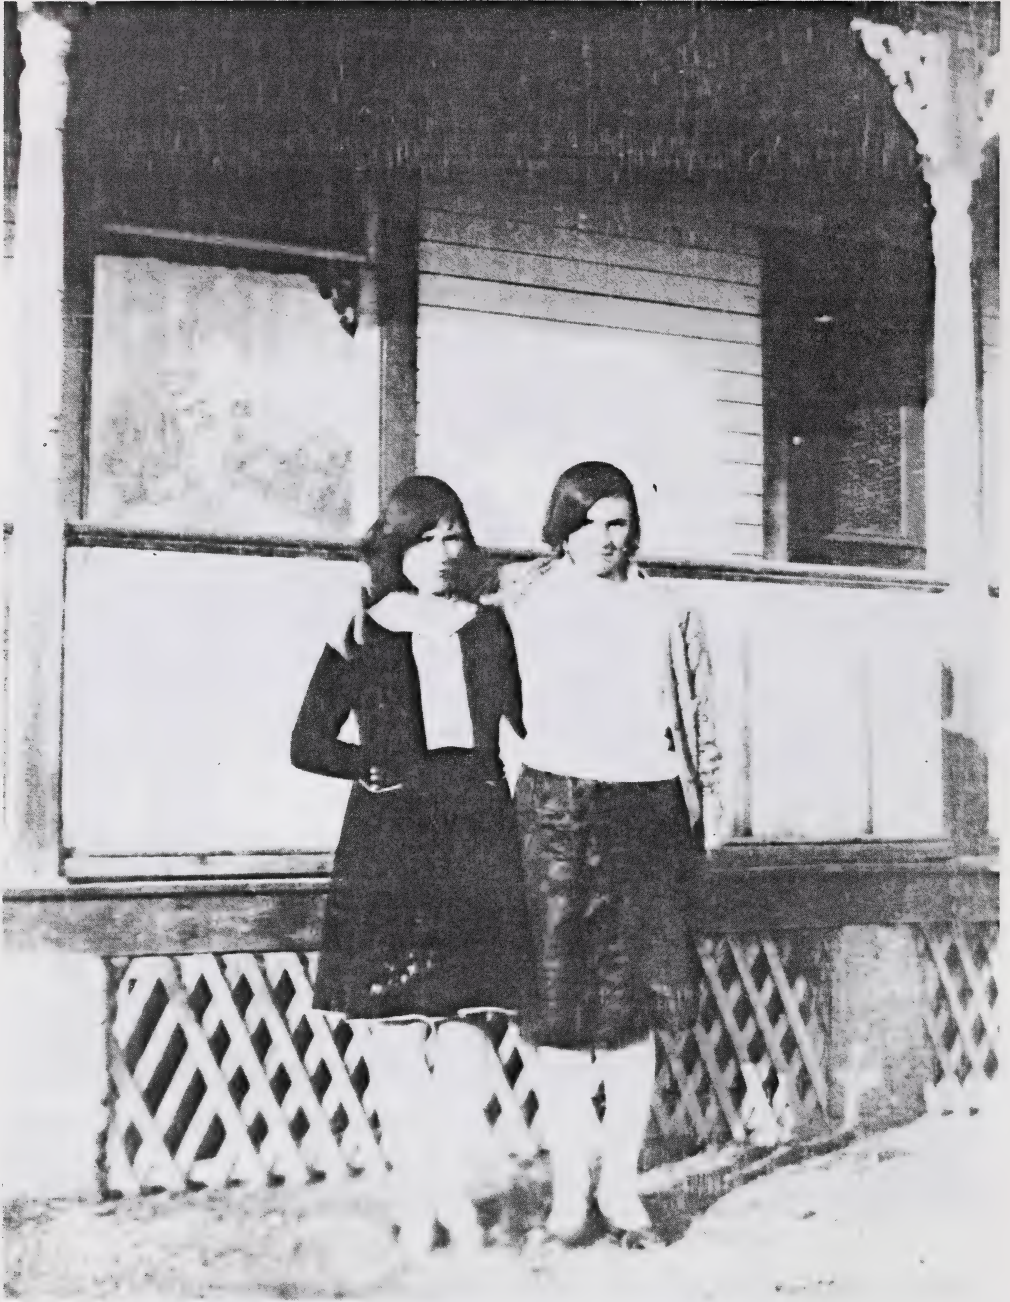
Figure 43: Nancy Hawreliak (left) and Lena Sokal in front of the south veranda, late 1920s. Note the missing lattice strips.

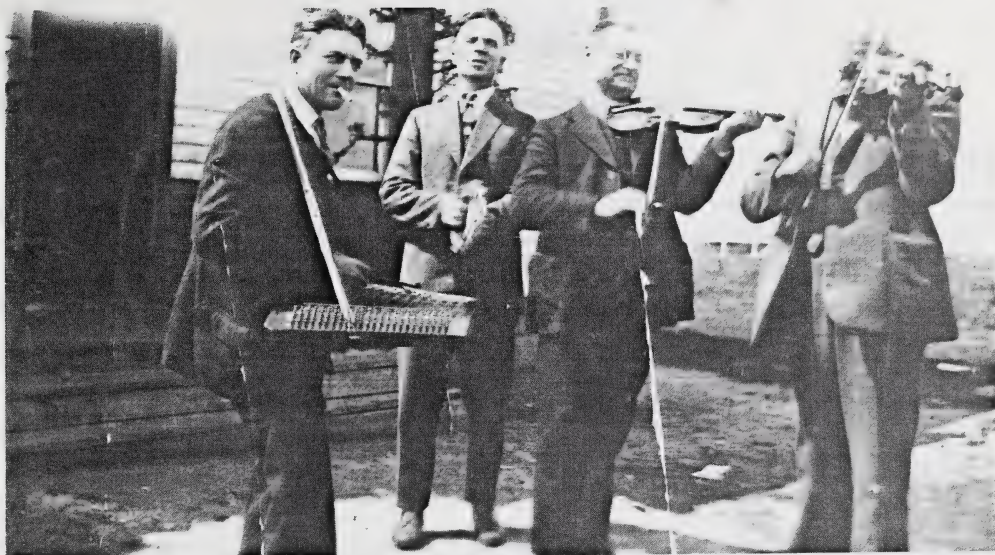
Figure 44: The orchestra at Mary (Hawreliak) Repka's wedding, June 7, 1928. The inner railing of the east entrance-way and the adjoining house wall are dark-coloured.

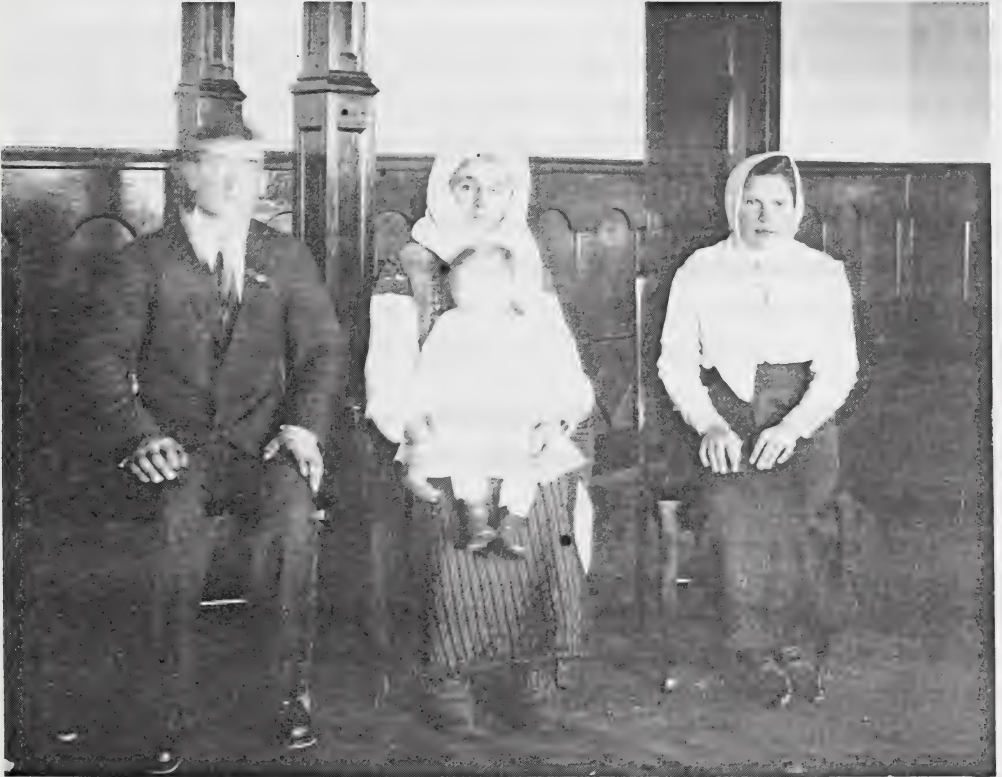
Figure 45: The "party" room in Nick S. Shandro's house. The location of the posts corresponds to the position of the living room/ dining room wall in the Hawreliak house. The wainscoting on the lower walls is identical to that used in the Hawreliak living room.
